BUILDING MATERIALS AND STRUCTURES

REPORT BMS22

Structural Properties of
"Dun-Ti-Stone" Wall
Construction Sponsored by the
W. E. Dunn Manufacturing
Company

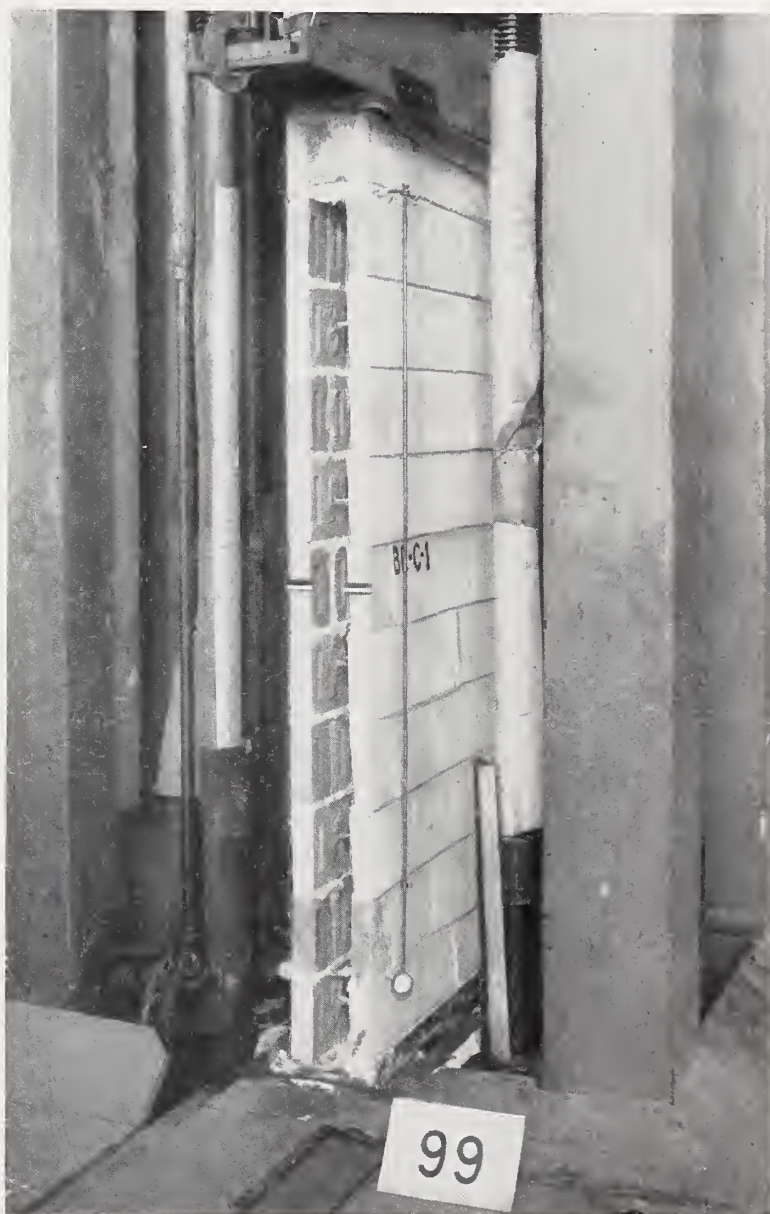
FIGURE 3.—Wall specimen *BE-C1*
under compressive load.

Wall specimen *BE-C1* under compressive load is shown in figure 3. The results for wall specimens *BE-C1*, *C2*, and *C3* are shown in table 6 and in figures 4 and 5.

Each of the specimens failed by crushing of units in the backing in two courses either at midheight or near the upper end, cracking of the backing vertically through about four courses, and rupture of the bond between the units and the mortar at one or two bed joints in the facing at the height at which the units in the backing crushed.

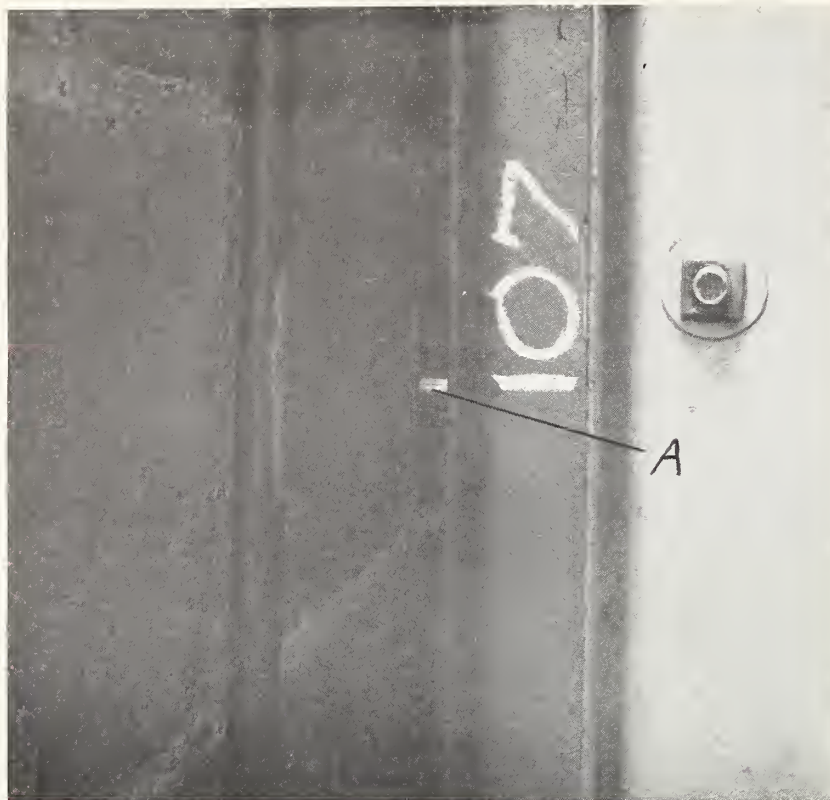
FIGURE 9.—Wall specimen BE-P1 under concentrated load.

A, loading disk.

Wall specimen *BE-P1* under concentrated load is shown in figure 9. The results are shown in table 6 and in figure 10 for wall specimens *BE-P1*, *P2*, and *P3*, loaded on the inside face, and in figure 11 for wall specimens *BE-P4*, *P5*, and *P6*, loaded on the outside face.

The concentrated loads were applied to the mortar bed and head joints at midwidth for all specimens except *P6*, to which the load was applied on a concrete unit. The indentations after a load of 1,000 lb had been applied were 0.004, 0.007, 0.017, 0.005, 0.004, and 0.003 in.

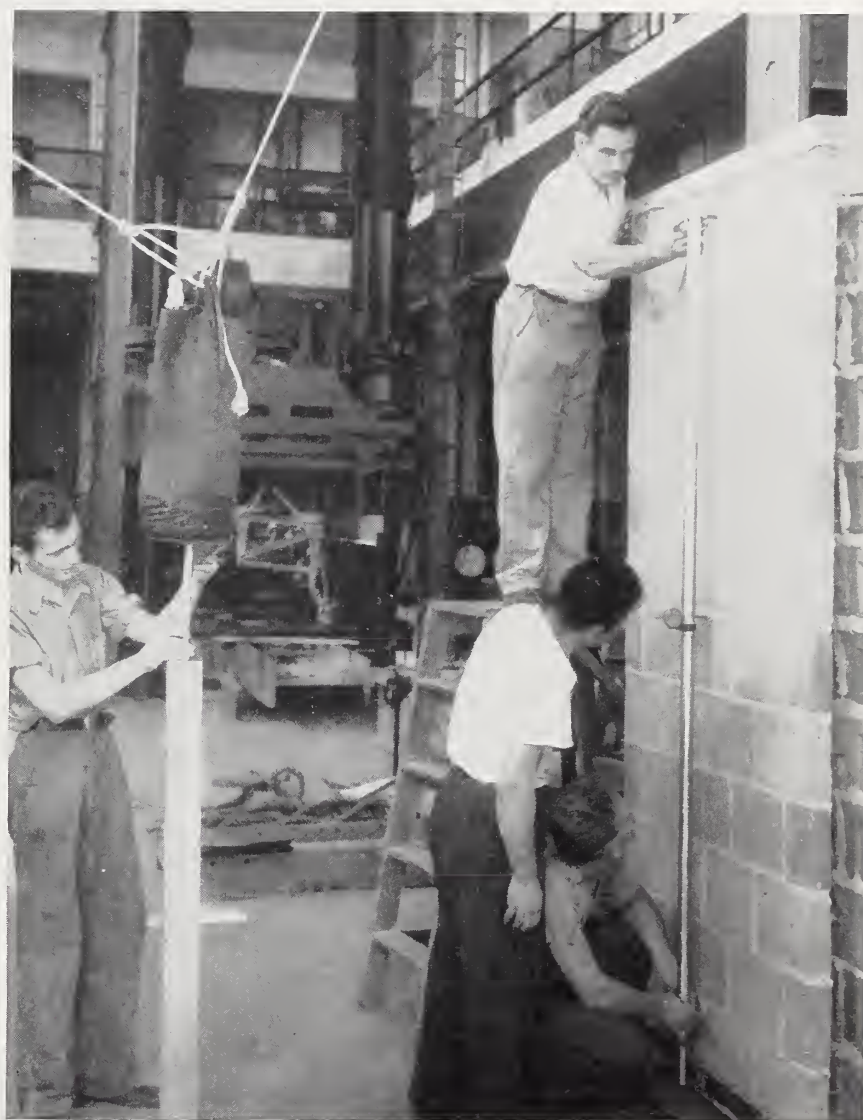
FIGURE 12.—Wall specimen *BE-I1* during the impact test.

Wall specimen *BE-I1* during the impact test is shown in figure 12. The results are shown in table 6 and in figure 13 for wall specimens *BE-I1*, *I2*, and *I3*, loaded on the inside face, and in figure 14 for wall specimens *BE-I4*, *I5*, and *I6*, loaded on the outside face.

At the drops given in table 6 the faces of each specimen failed by rupture of the bond between the units and the mortar at bed joints near

midspan. At the maximum drops, each specimen failed by opening of these joints.

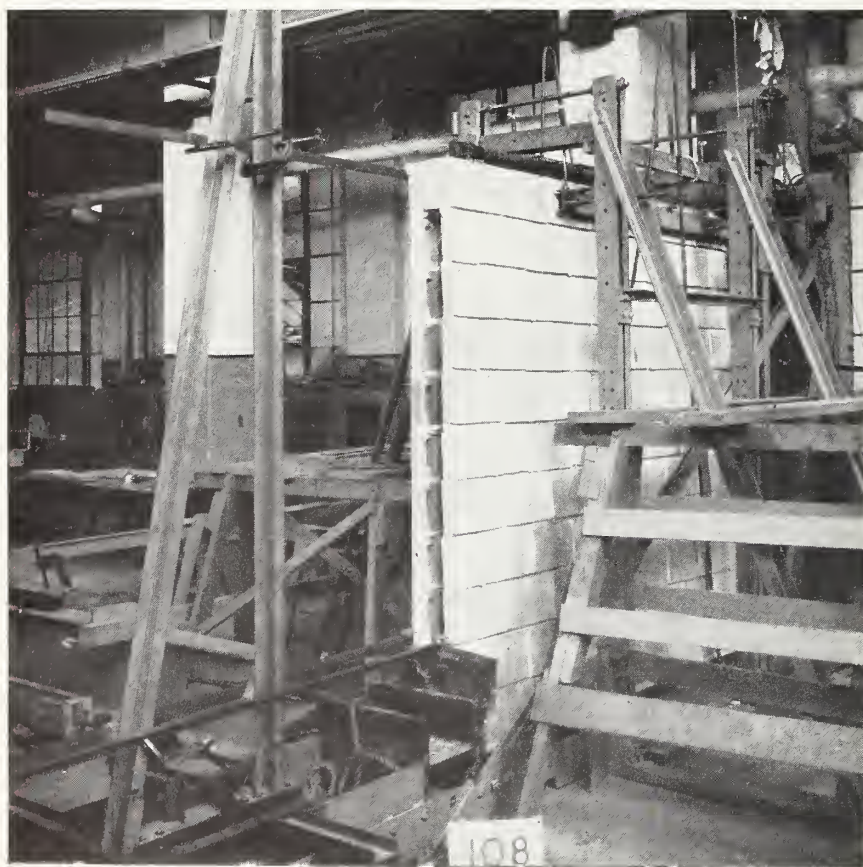
FIGURE 15.—Wall specimen BE-R1 under racking load.

Wall specimen BE-R1 under racking load is shown in figure 15. The results for wall specimens BE-R1, R2, and R3 are shown in table 6 and in figure 16.

The racking loads were applied to the top course and the stop was in contact with the first and second courses from the lower end. For specimen R3 at a load of 1.188 kips/ft, a head joint at the end of a unit near the loaded corner cracked. At the maximum load, each of the specimens failed by rupture of the bed and head joints in stepwise cracks approximately along a diagonal between the point of application of load and the stop. In addition, for specimens R1 and R2 the two top courses sheared off by rupture of the bond between the units and the mortar in the bed joint, and for specimen R3 the bond between the units and the mortar ruptured in a bed joint between the sixth and seventh courses.
